ONTARIO WATER RESOURCES COMMISSION

CITY OF WINDSOR

TREE INJURY COMPLAINT

REPORT ON FIELD INVESTIGATIONS

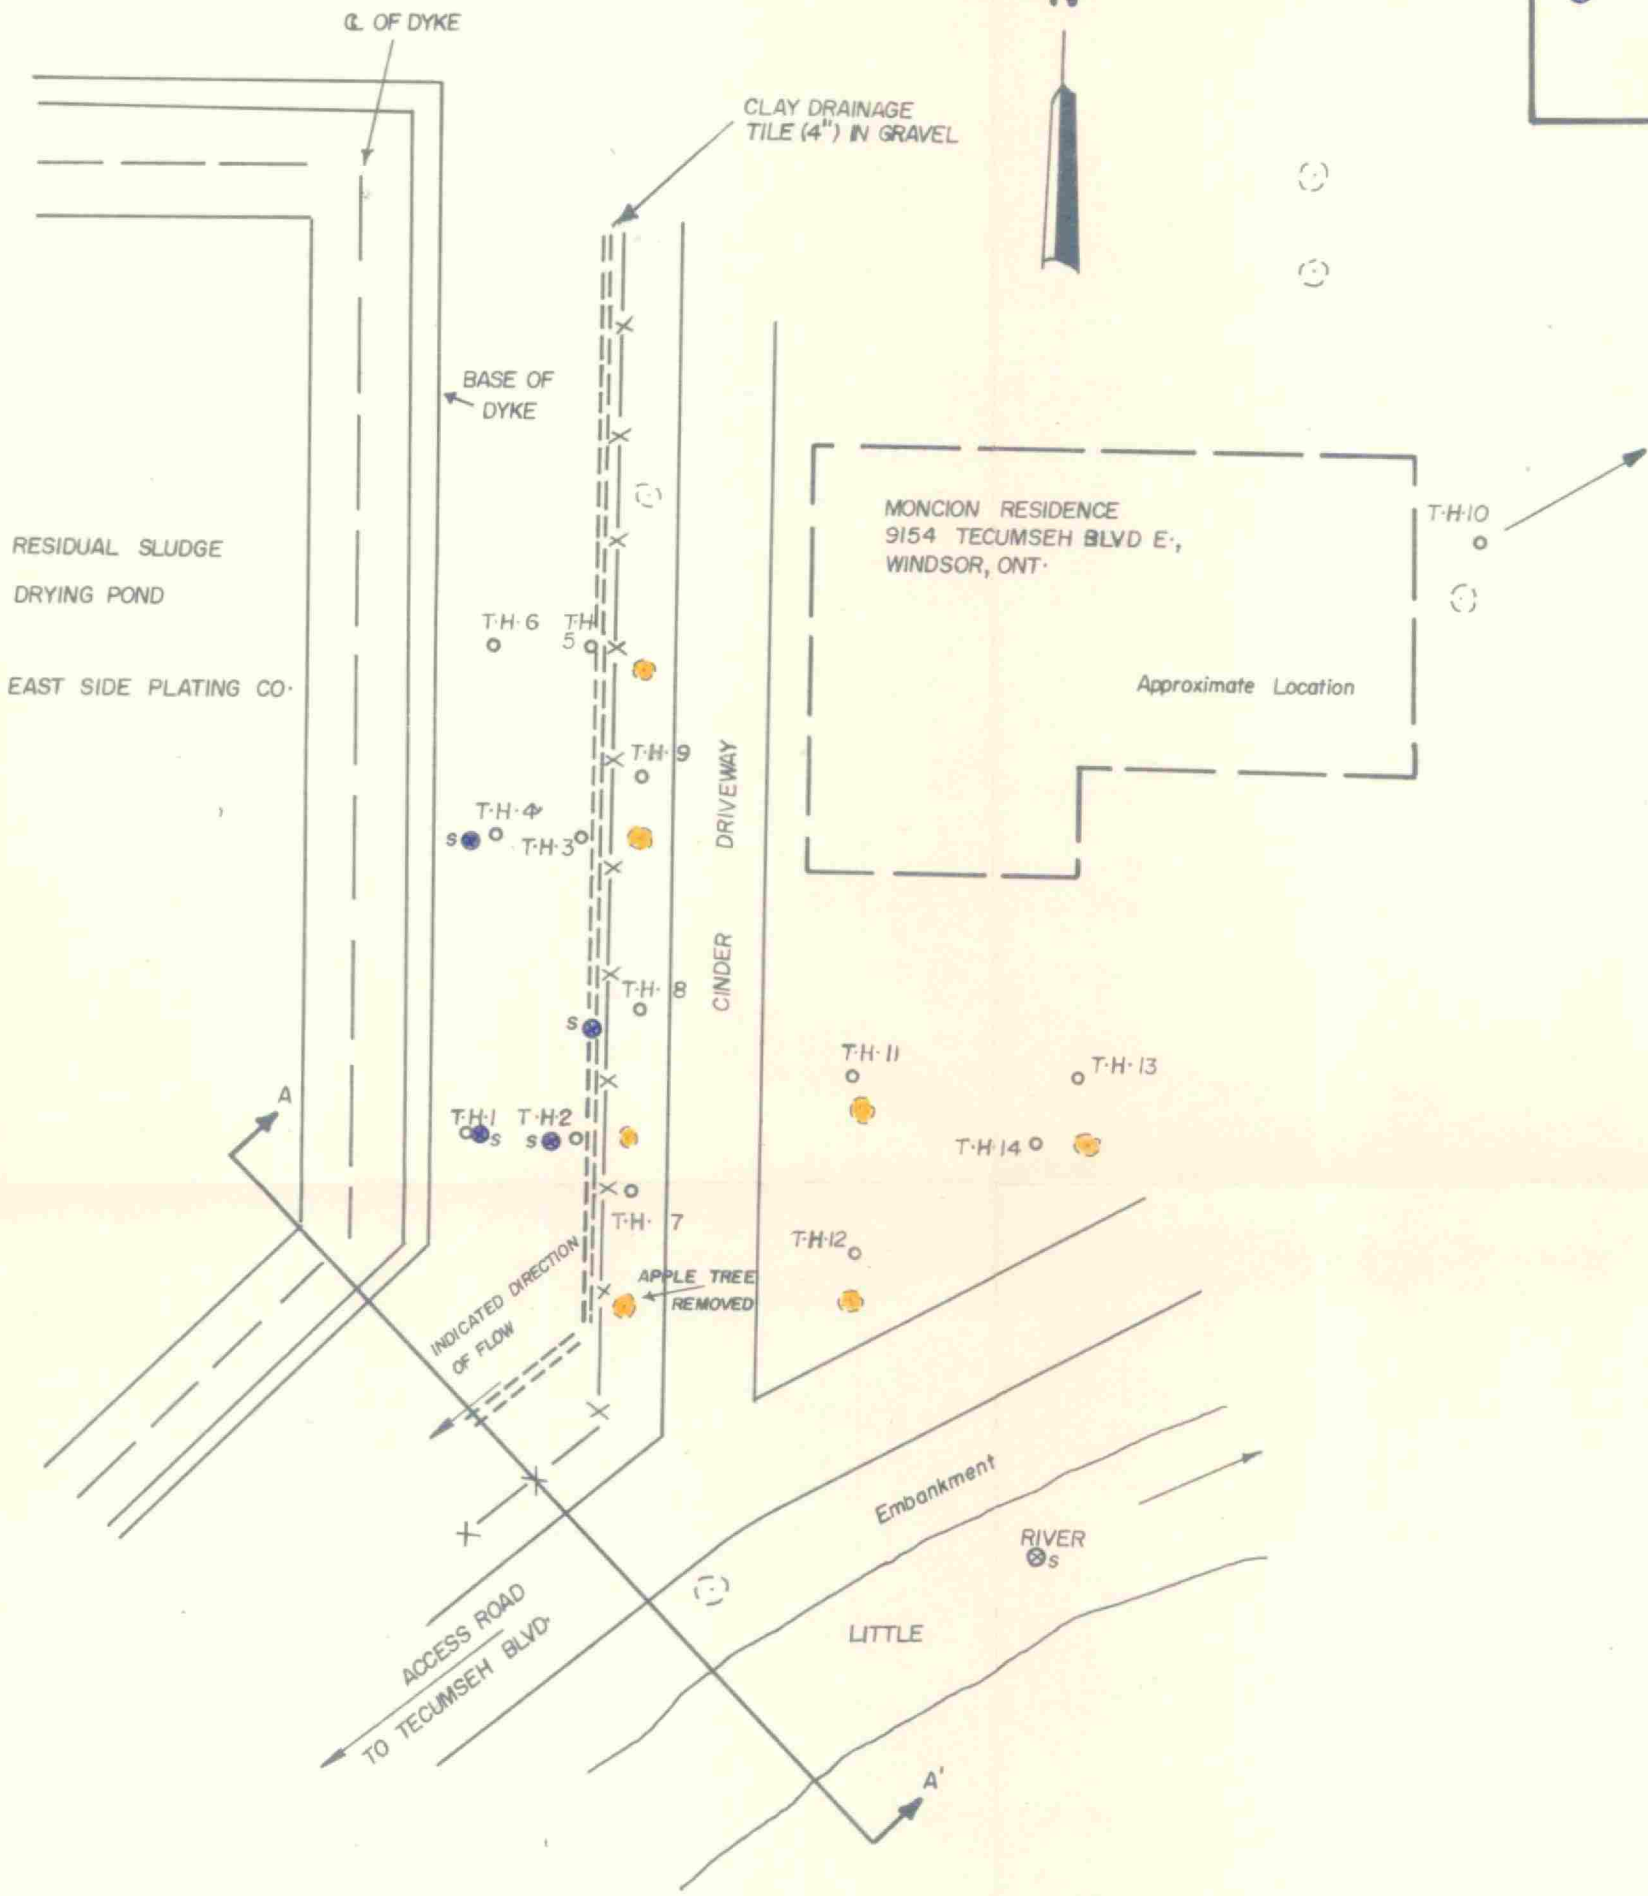
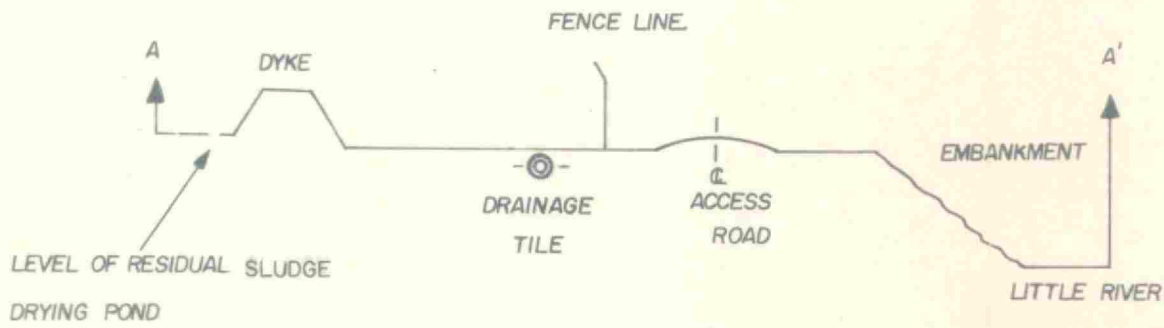
FIGURE 1

Two-inch diameter holes were hand-augered into the overburden near the affected trees and at varying distances from the sludge-drying pond. The locations of the auger holes are shown on Figure 1. Soil and water samples were collected from several of the auger holes for chemical analyses. The Plant Manager of the East Side Plating Company, Mr. E. Snow, and Mrs. Moncion were interviewed during the investigation.

From auger-hole data, the overburden to a depth of three feet generally consisted of a grey, gritty clay and some sand with a low moisture content. Water was encountered in test holes 1, 2 and 4. The water rose rapidly in test hole 1 to ground surface, indicating hydraulic connection with the sludge pond and good permeability. The water in test holes 2 and 4 rose more slowly, indicating poorer lateral permeability. The gradient of the water levels in the auger holes was toward the Little River. Water did not enter the other auger holes adjacent to the dyke because the overburden comprised clay entirely. The clay tile drainage system at the time of the inspection appeared to be operating satisfactorily. Surface drainage in the area was being intercepted.

The most seriously damaged trees are located adjacent to, and down-gradient from, the sludge pond. From the apparent gradient of the water levels in the auger holes, the direction of ground-water movement is deduced to be toward the Little River from the area of the sludge pond. The affected trees are located between the river and the sludge pond. The root systems of these trees may also have extended beneath the sludge pond. Some leakage and movement of industrial waste from the sludge pond is evident from the chemical analyses of water samples from auger holes 1, 2 and 4.

The drainage tile system installed by the East Side Plating Company along its easterly property line is only partially effective, because of its shallowness, in preventing the movement of waste to adjacent property. From the auger-hole data, it appears that some ground water moves beneath the tile system. Surface water runoff and leakage through the dyke is being intercepted by the tile system. The installation of a tile system at greater depth may result in the interception of more effluent but the discharge to the Little River would be more direct and further contaminate the river. There is no insurance that this corrective measure will prevent further injury to the trees.
